Manhole Inspection Summary

Manhole # S49CC_053MH

Manhole Type: **Junction** Location: **Alley**

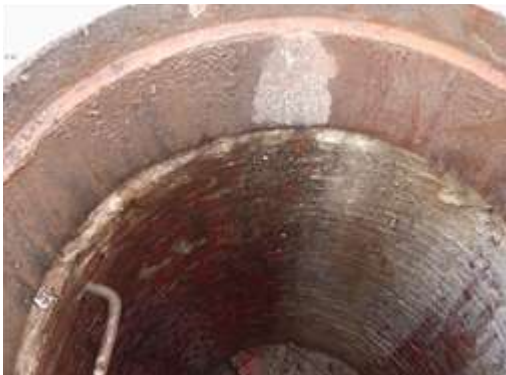
Defect 3

frame leaks

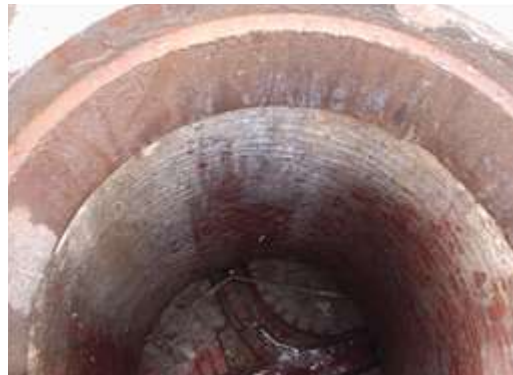
Defect 2

frame leaks

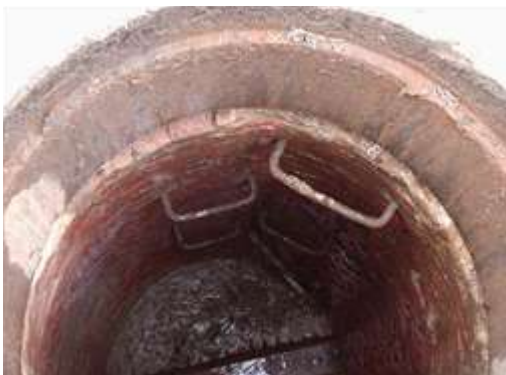
Defect 1

adjustment frame

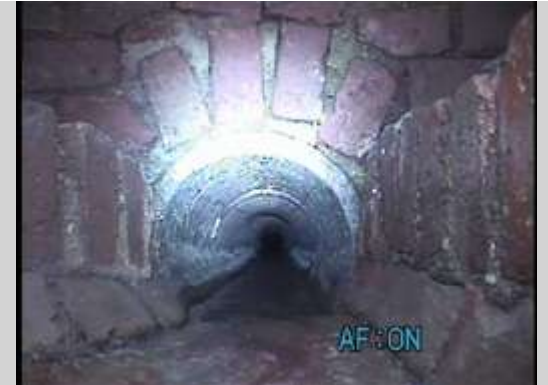
12 O'Clock Outflow

Pipe Height: **8.4** (in.) Rod and Bar (Angled)
Pipe Material: **Clay** ☐ Pipe Lined
Invert Depth: **9.50** (ft.) Flow Characteristics: **Fast**
Deposits: ☒ None ☐ Mud ☐ Sludge ☐ Debris ☐ Grease
Silt Depth: (in.) Deposits Extent:
Infiltration: **None** Pipe Seal Cond: **Sound**

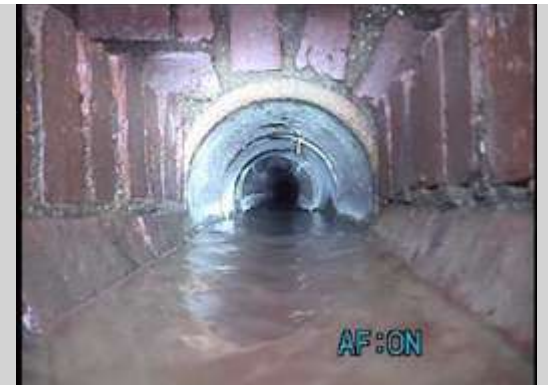
6 O'Clock Inflow

Pipe Height: **8.4** (in.) Rod and Bar (Angled)
Pipe Material: **Clay** ☐ Pipe Lined
Invert Depth: **9.45** (ft.) Flow Characteristics: **Fast**
Deposits: ☒ None ☐ Mud ☐ Sludge ☐ Debris ☐ Grease
Silt Depth: (in.) Deposits Extent:
Infiltration: **None** Pipe Seal Cond: **Sound**

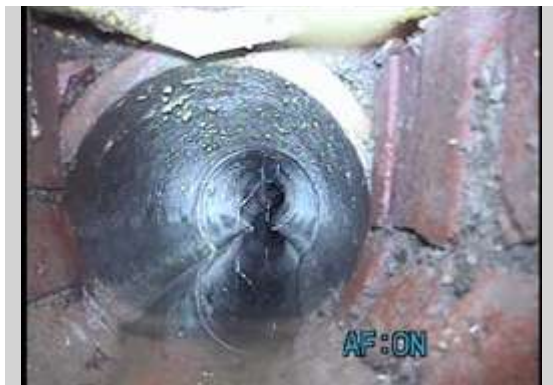
9 O'Clock Inflow

Infiltration: **None** Pipe Seal Cond: **Sound**
